# Low-cost methods of rainwater storage

Results from field trials in  
Ethiopia and Kenya

## **RELMA Technical Report (TR) series**

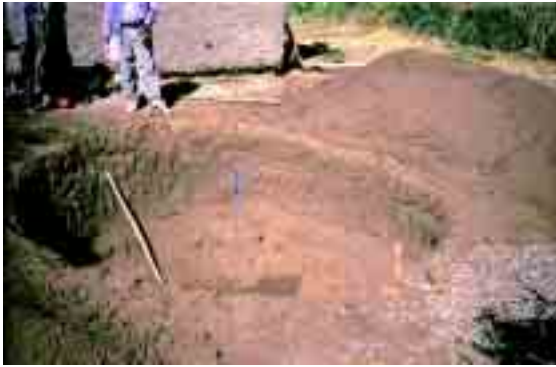
**Plate 2.1** Excavation of hemispherical tank.

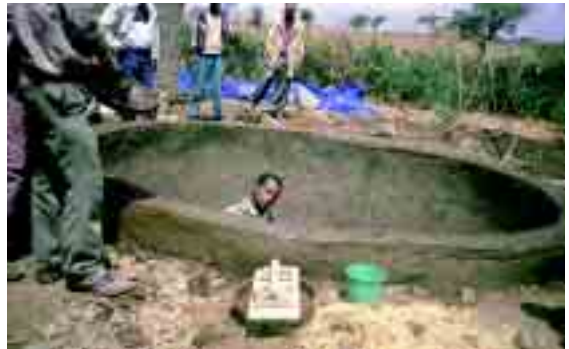
**Plate 2.2** Completion of tank lining.

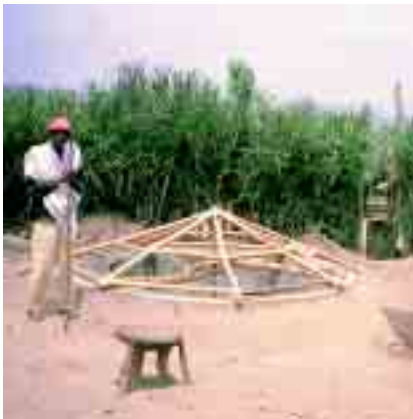
**Plate 2.3** Construction of roof.

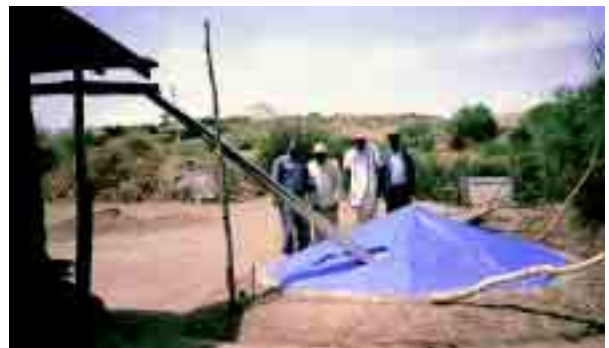
**Plate 2.4** Completed tank with gutters and delivery pipe installed.

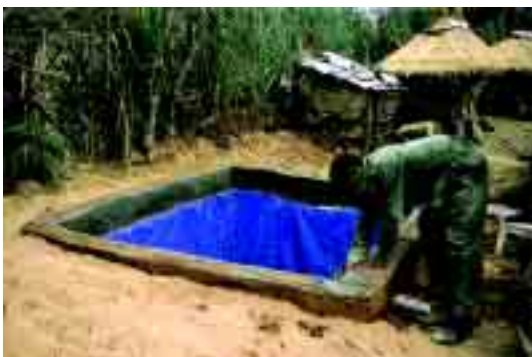
**Plate 2.5** Rectangular tank with polythene lining.

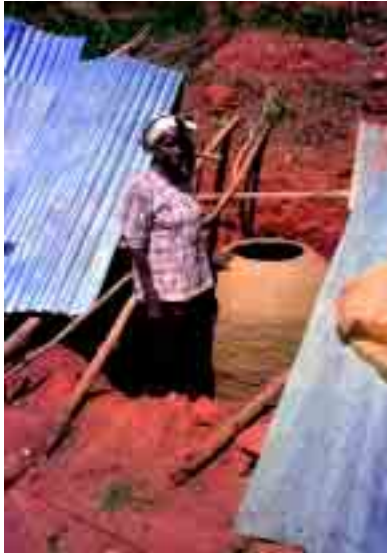
**Plate 3.1** Self-standing underground ceramic tank after firing but before back-filling with soil.

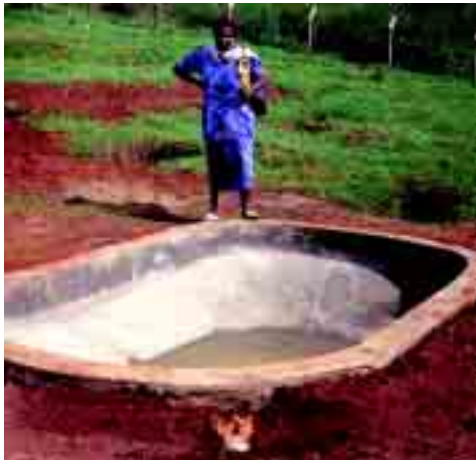
**Plate 3.3** Oval tank lined with cement-sand mortar reinforced with sisal.

This tank was not covered (Plate 3.3).

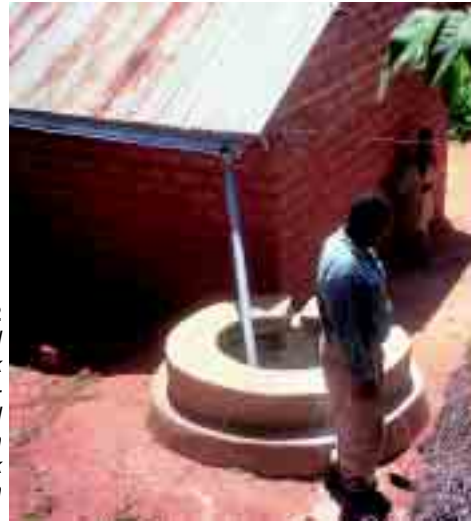
**Plate 3.2** Completed ceramic tank after back-filling and construction of the neck with brickwork.

After completion of the firing process, the space around the tank was back-filled with soil, which was well compacted to give structural support. The final stage was to construct a mouth for the tank using a double-layered course of bricks up to a height of 0.5 m above the surface using a cement–sand mortar (1:5) (Plate 3.2). Curing of this section was continued by keeping it moist for 28 days. It was then plastered and sealed with a cement–water slurry (nil).

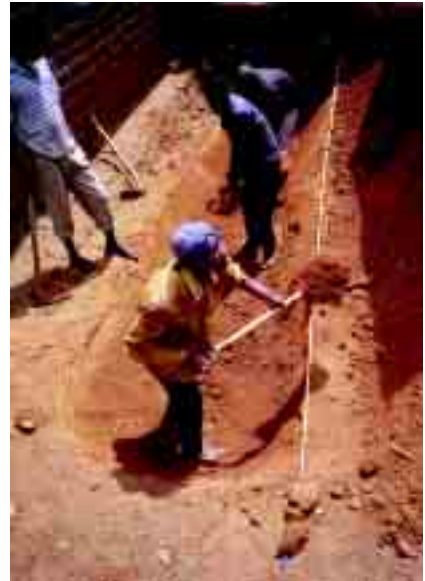
**Plate 3.4** Layout and excavation of sausage-shaped tank.

This is a long sausage-shaped structure half of which is underground (Figure 3.3 and Plates 3.4 and 3.5). It is circular in cross-section and slopes gently towards the outlet from where water is drawn. The trial tank in this study was constructed at Mr Kaunda's farm in Mwala Location, Machakos District.

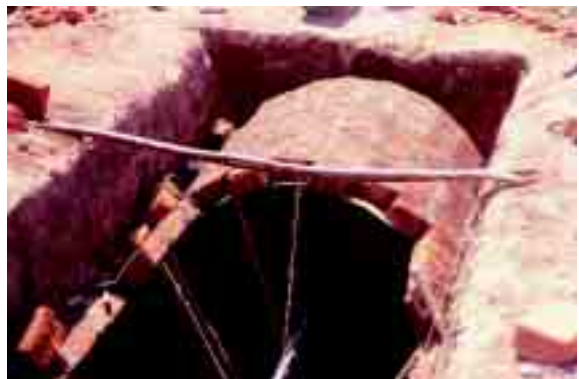
**Plate 3.5** Construction of sausage-shaped tank.
